**Joyful Work:  
Beach Profiling and Cove Sedimentation Edition**

# Beach Profiling

**Concerns by property owners prompted Stillwaters to conduct beach profiling to document changes in sedimentation patterns in the cove after culvert removal**

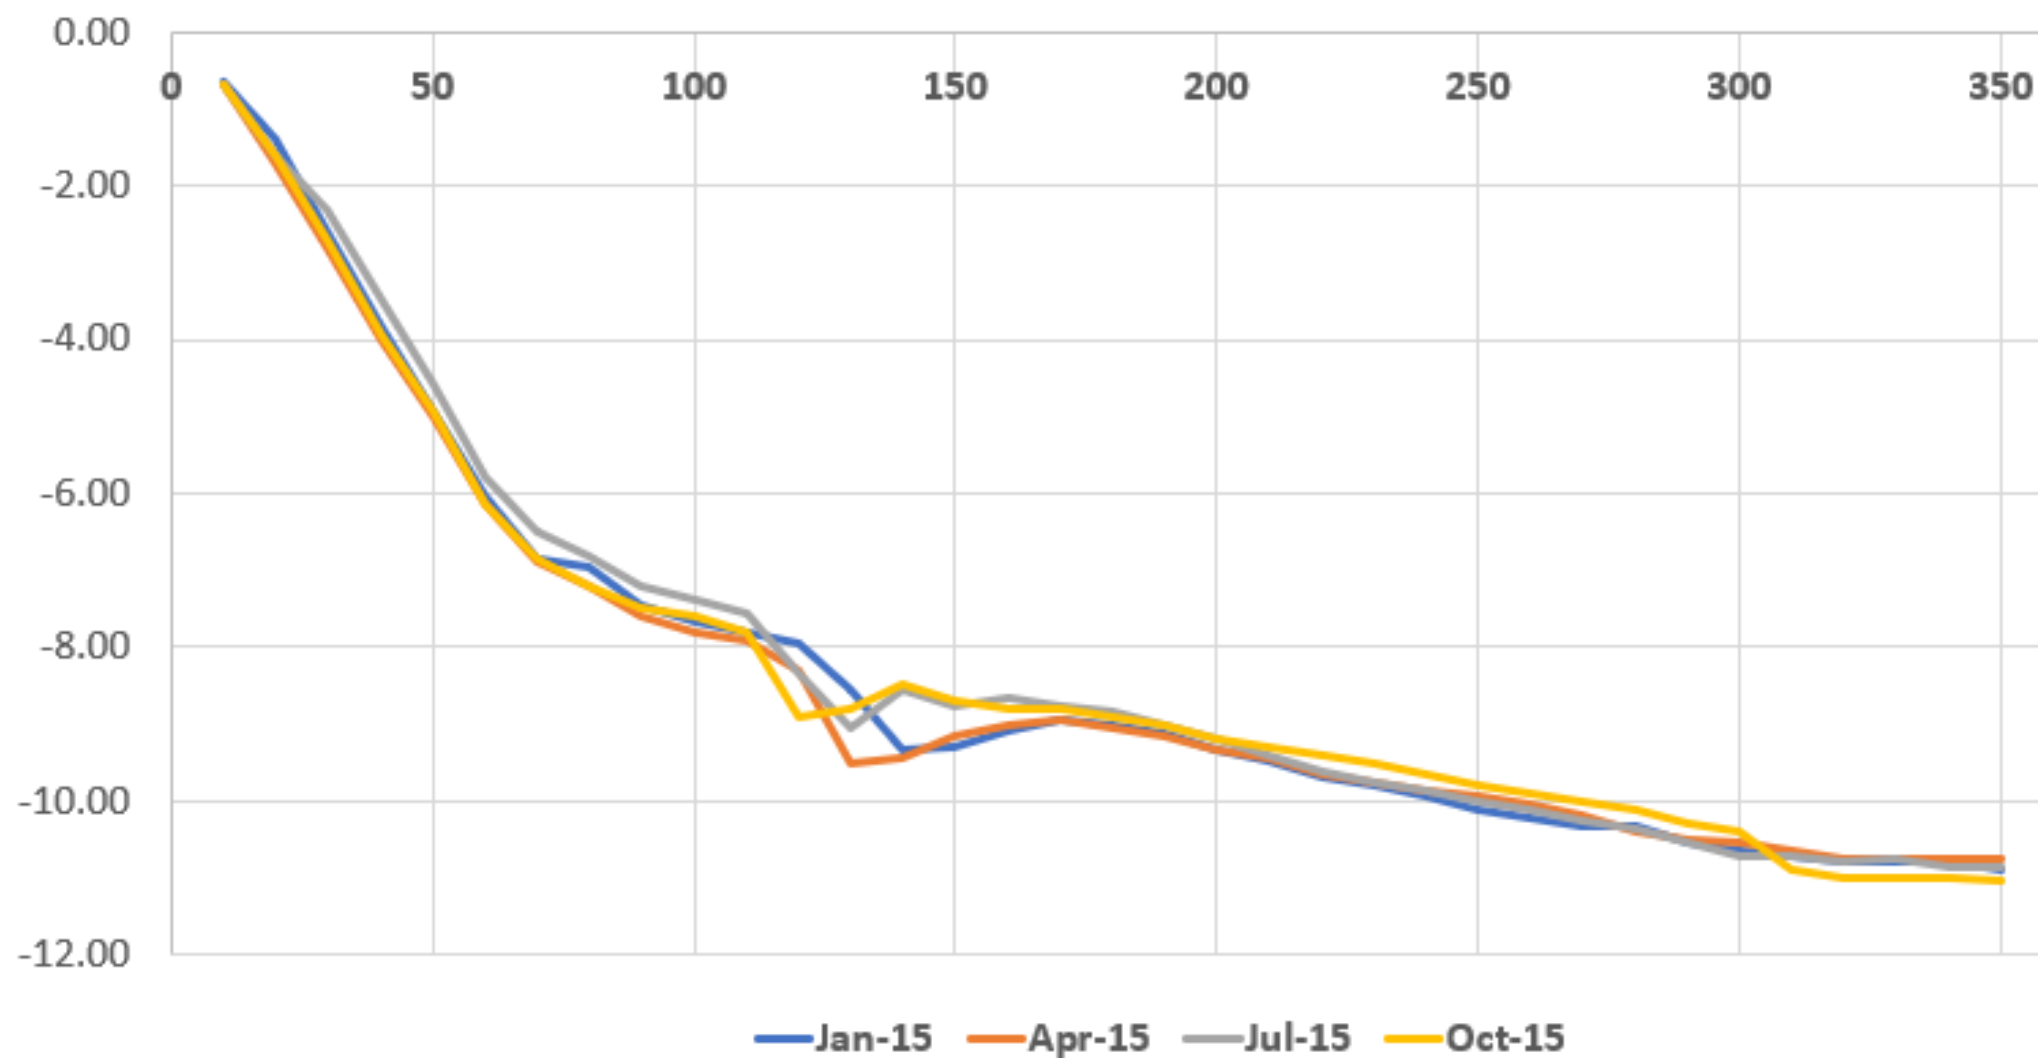
## Transect 1 Beach Profile

- allows you to take a snapshot (cross section) of a beach at a point in time
- taking the same snapshot in different months and/or years show changes over time
- changes may be due to wave action, currents or the placement or removal of man-made structures

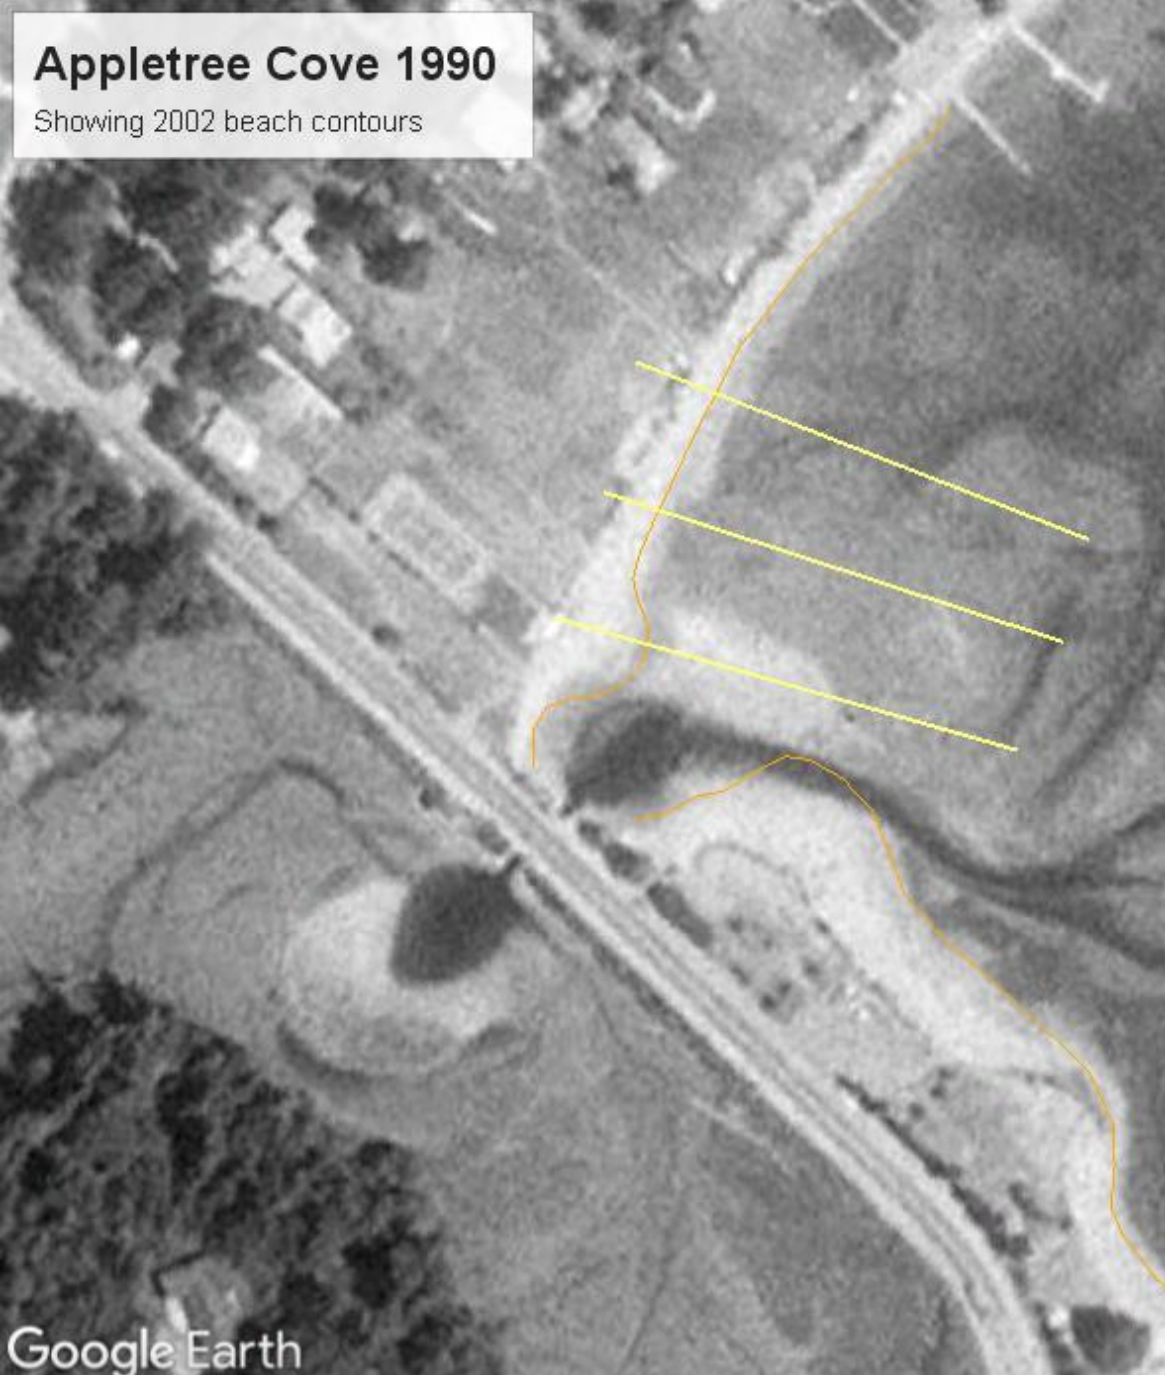
# Appletree Cove 1990

Showing 2002 beach contours

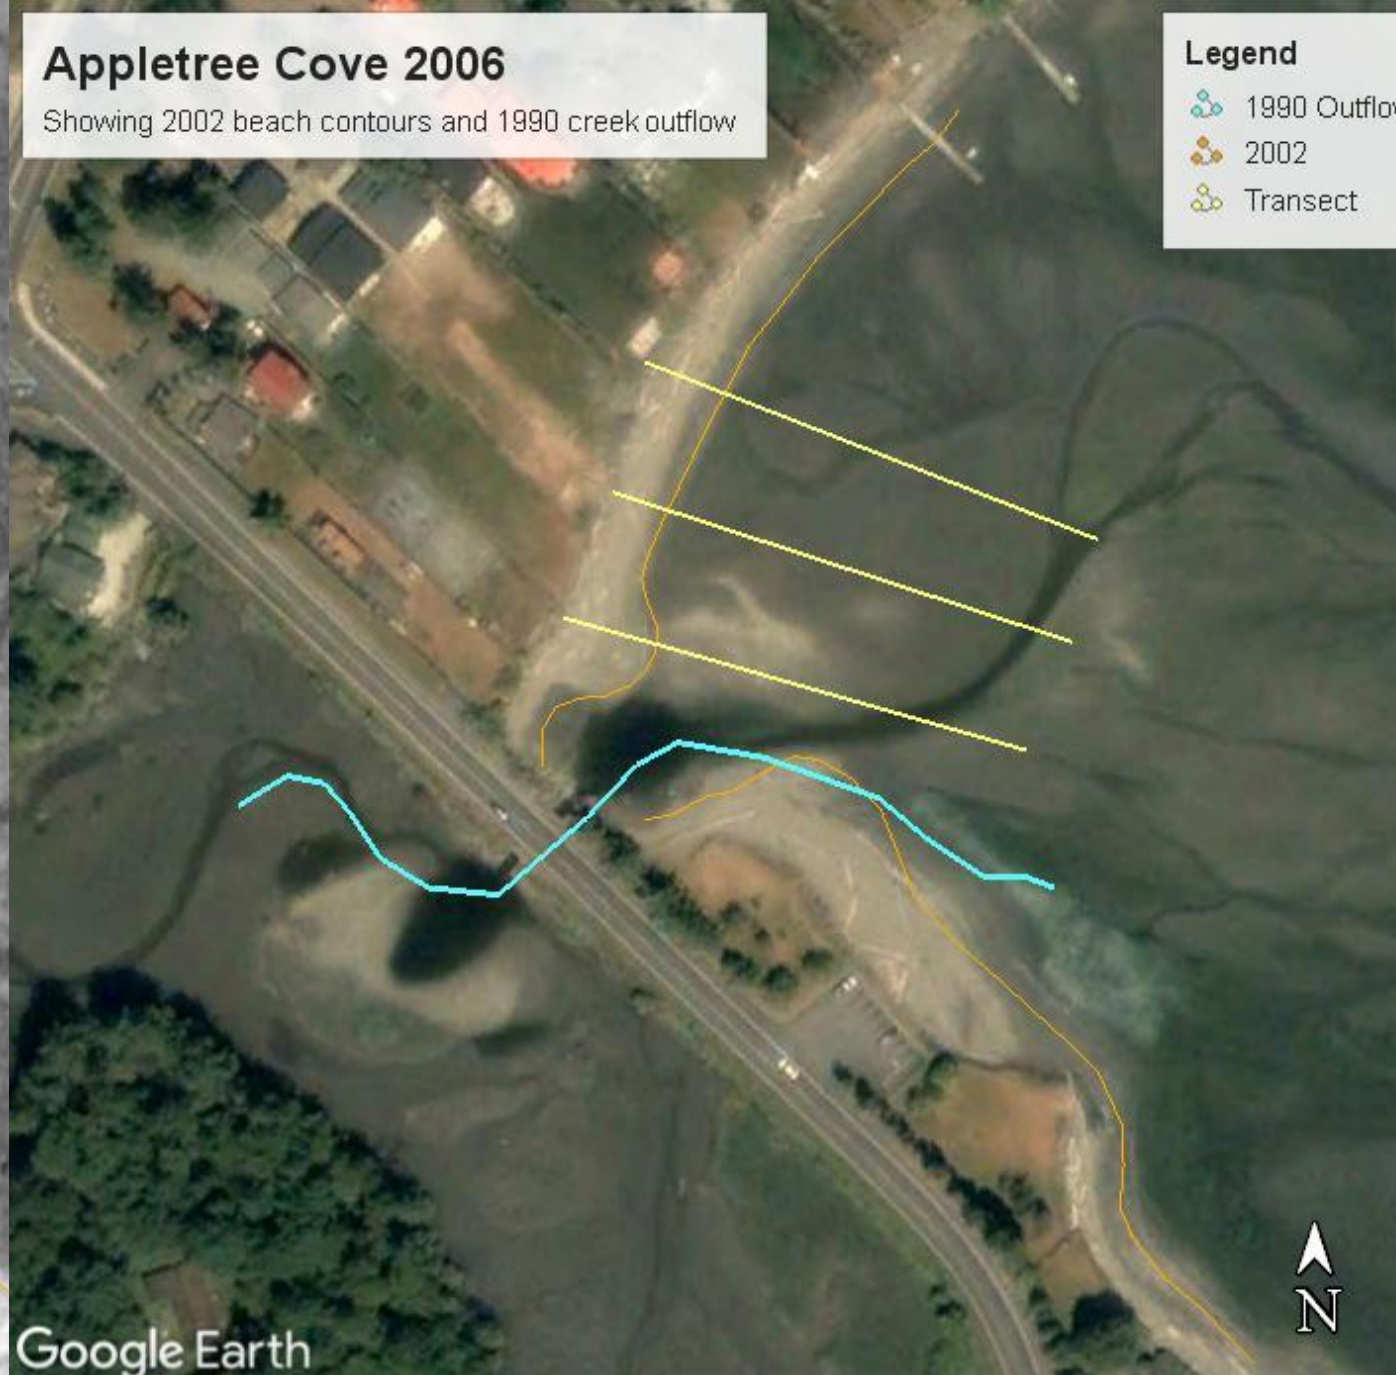
# Appletree Cove 2006

Showing 2002 beach contours and 1990 creek outflow

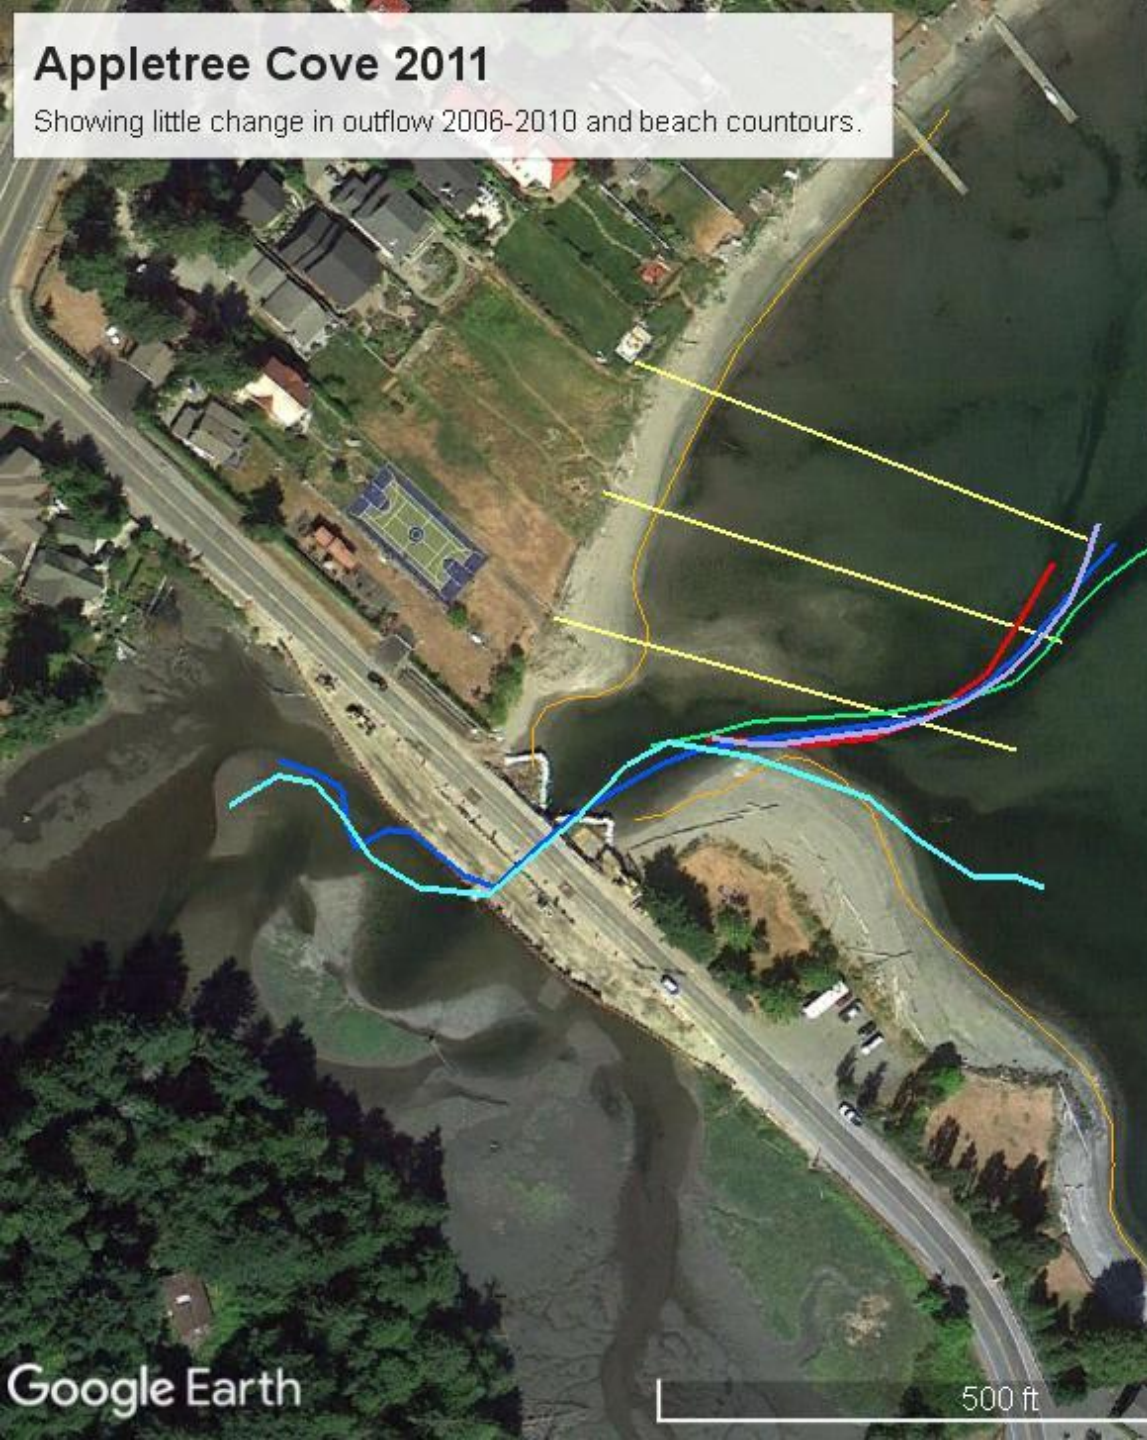
# Appletree Cove 2011

Showing little change in outflow 2006-2010 and beach countours.

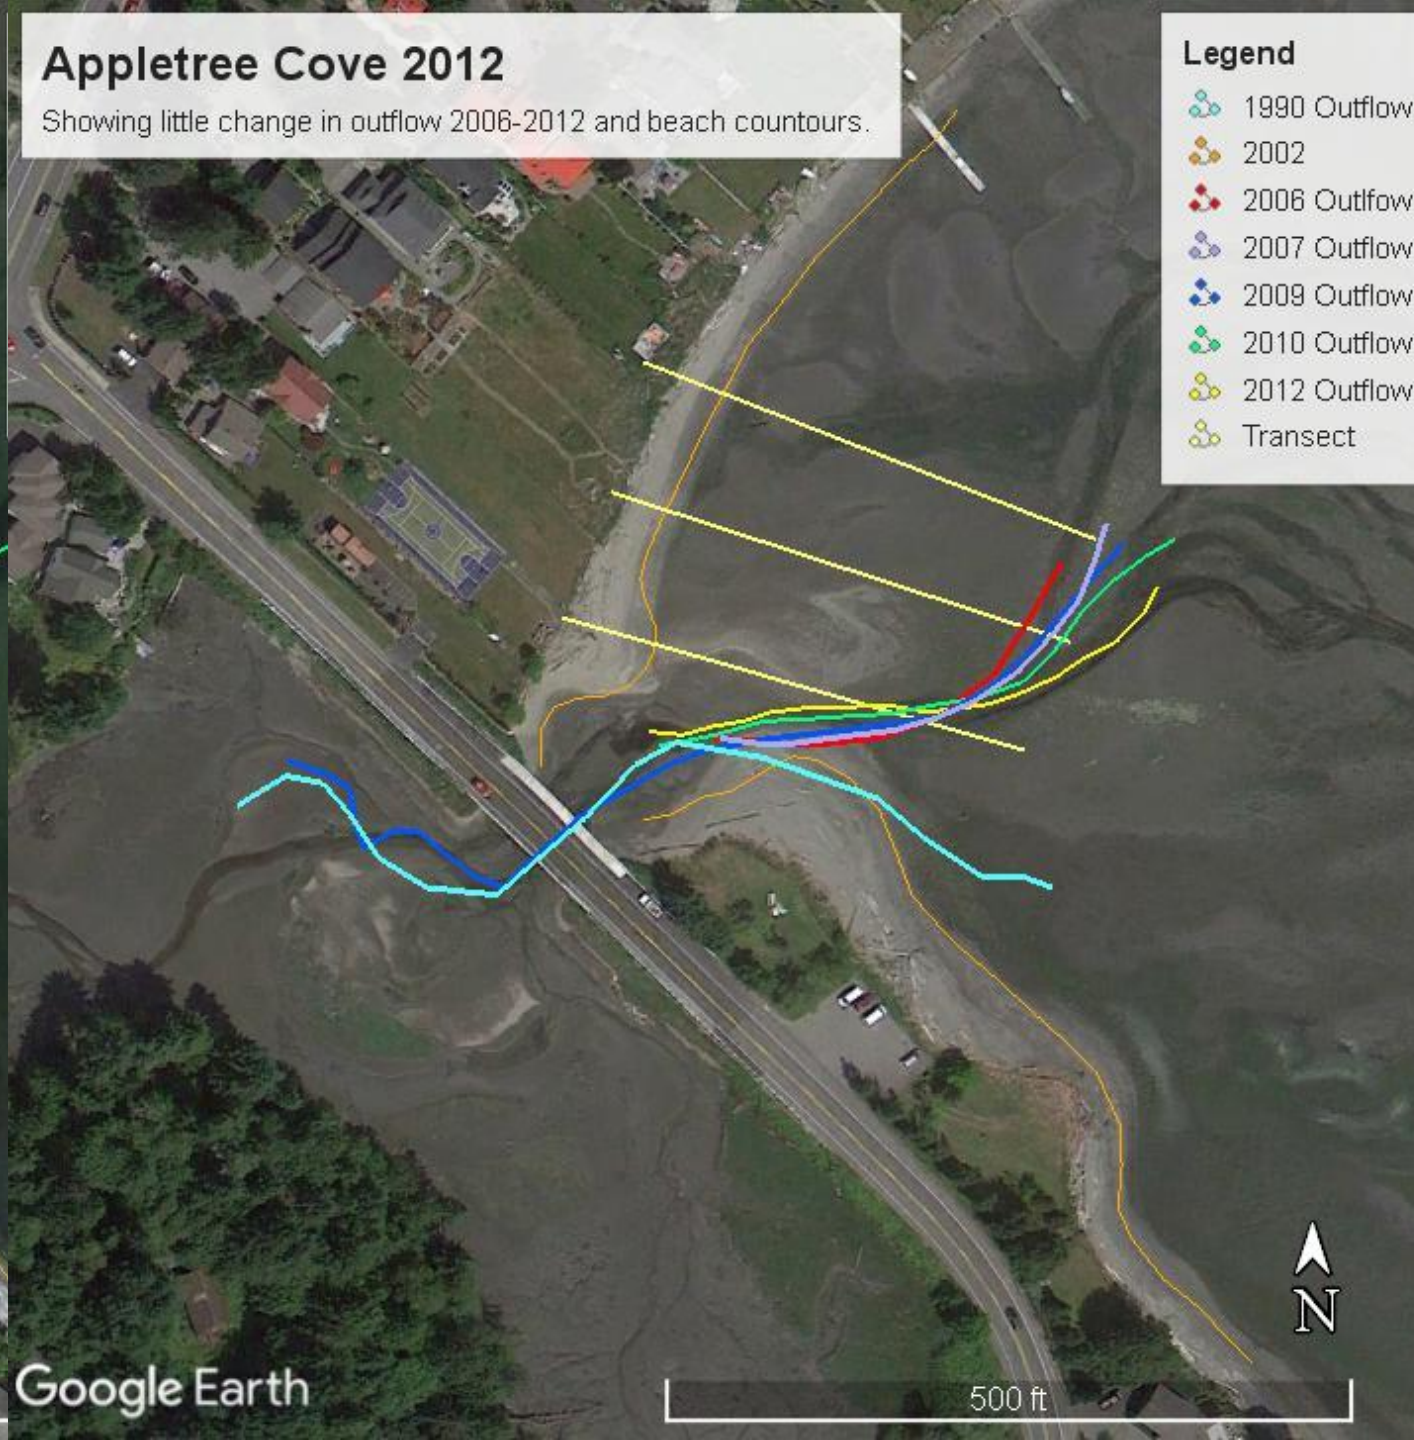
# Appletree Cove 2012

Showing little change in outflow 2006-2012 and beach countours.

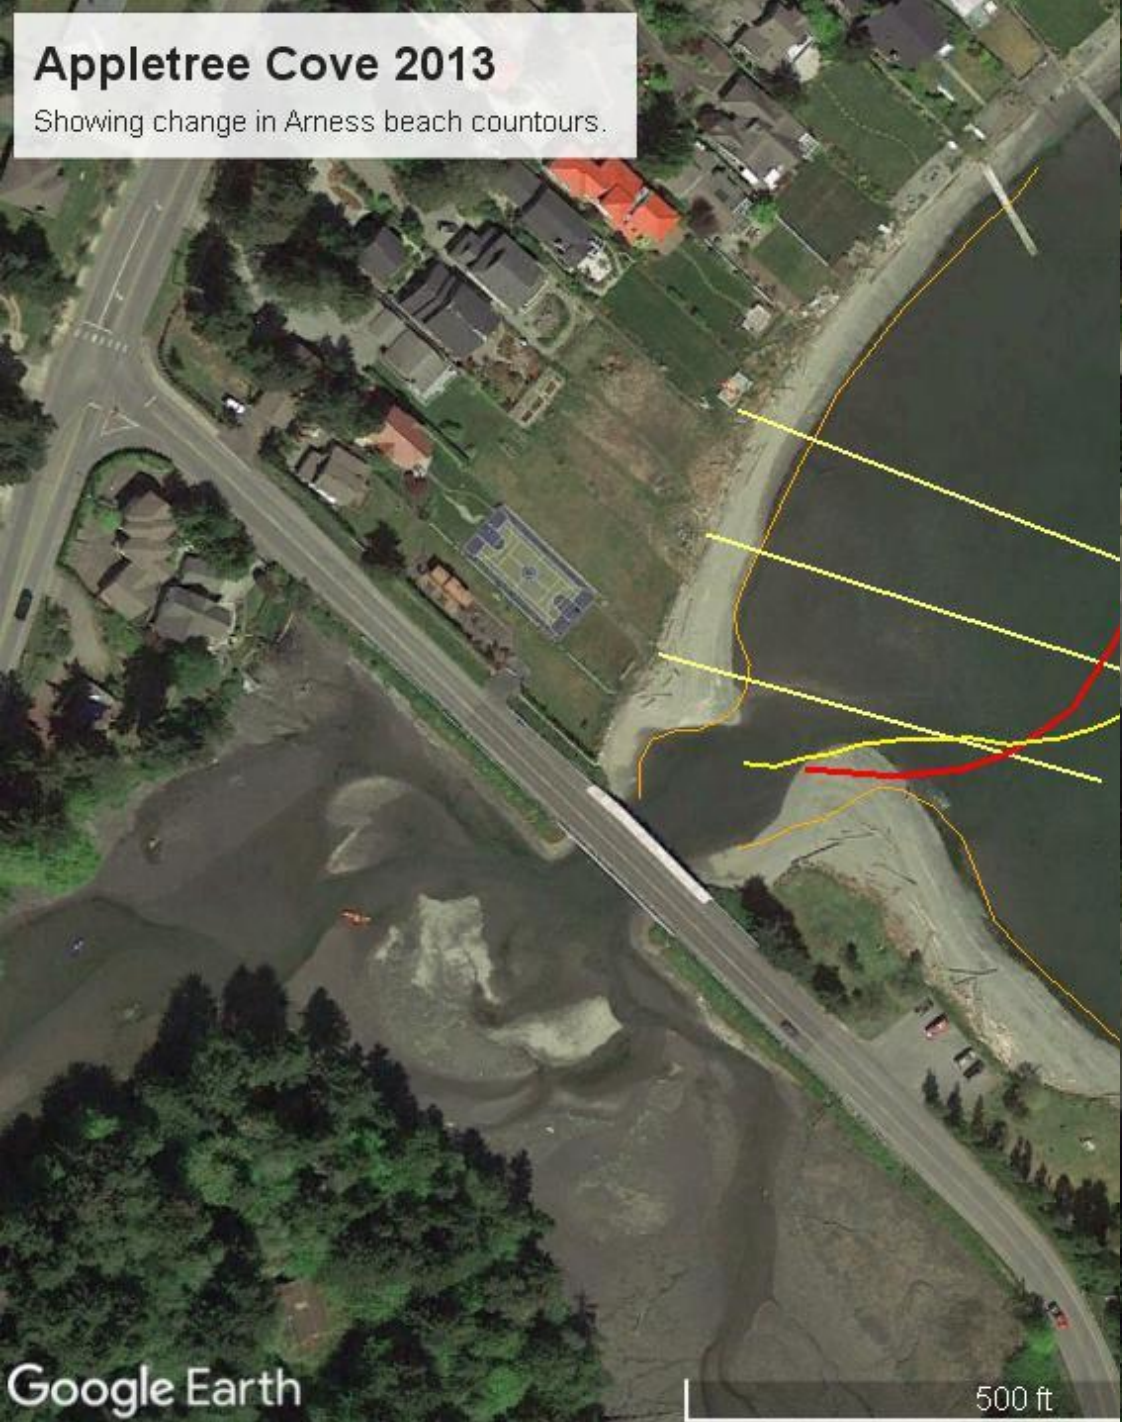
## Appletree Cove 2013

Showing change in Arness beach countours.

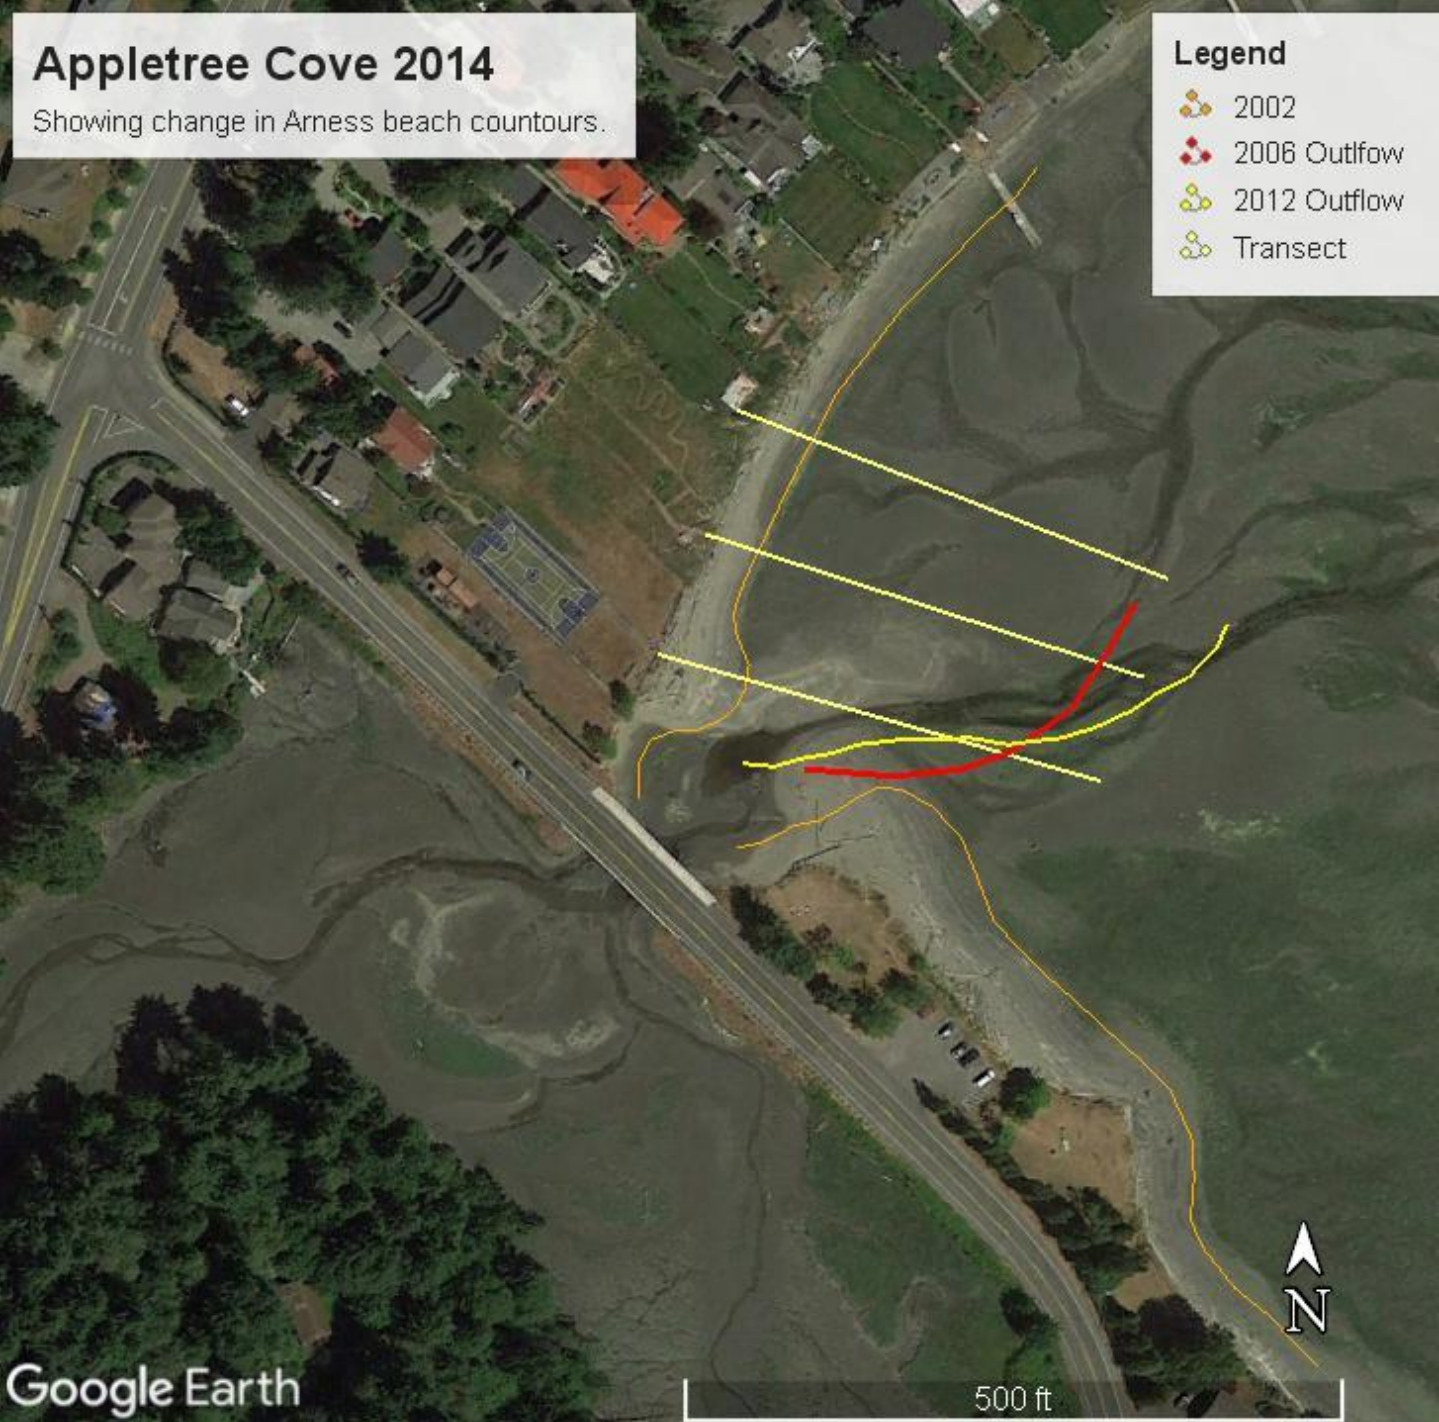
## Appletree Cove 2014

Showing change in Arness beach countours.

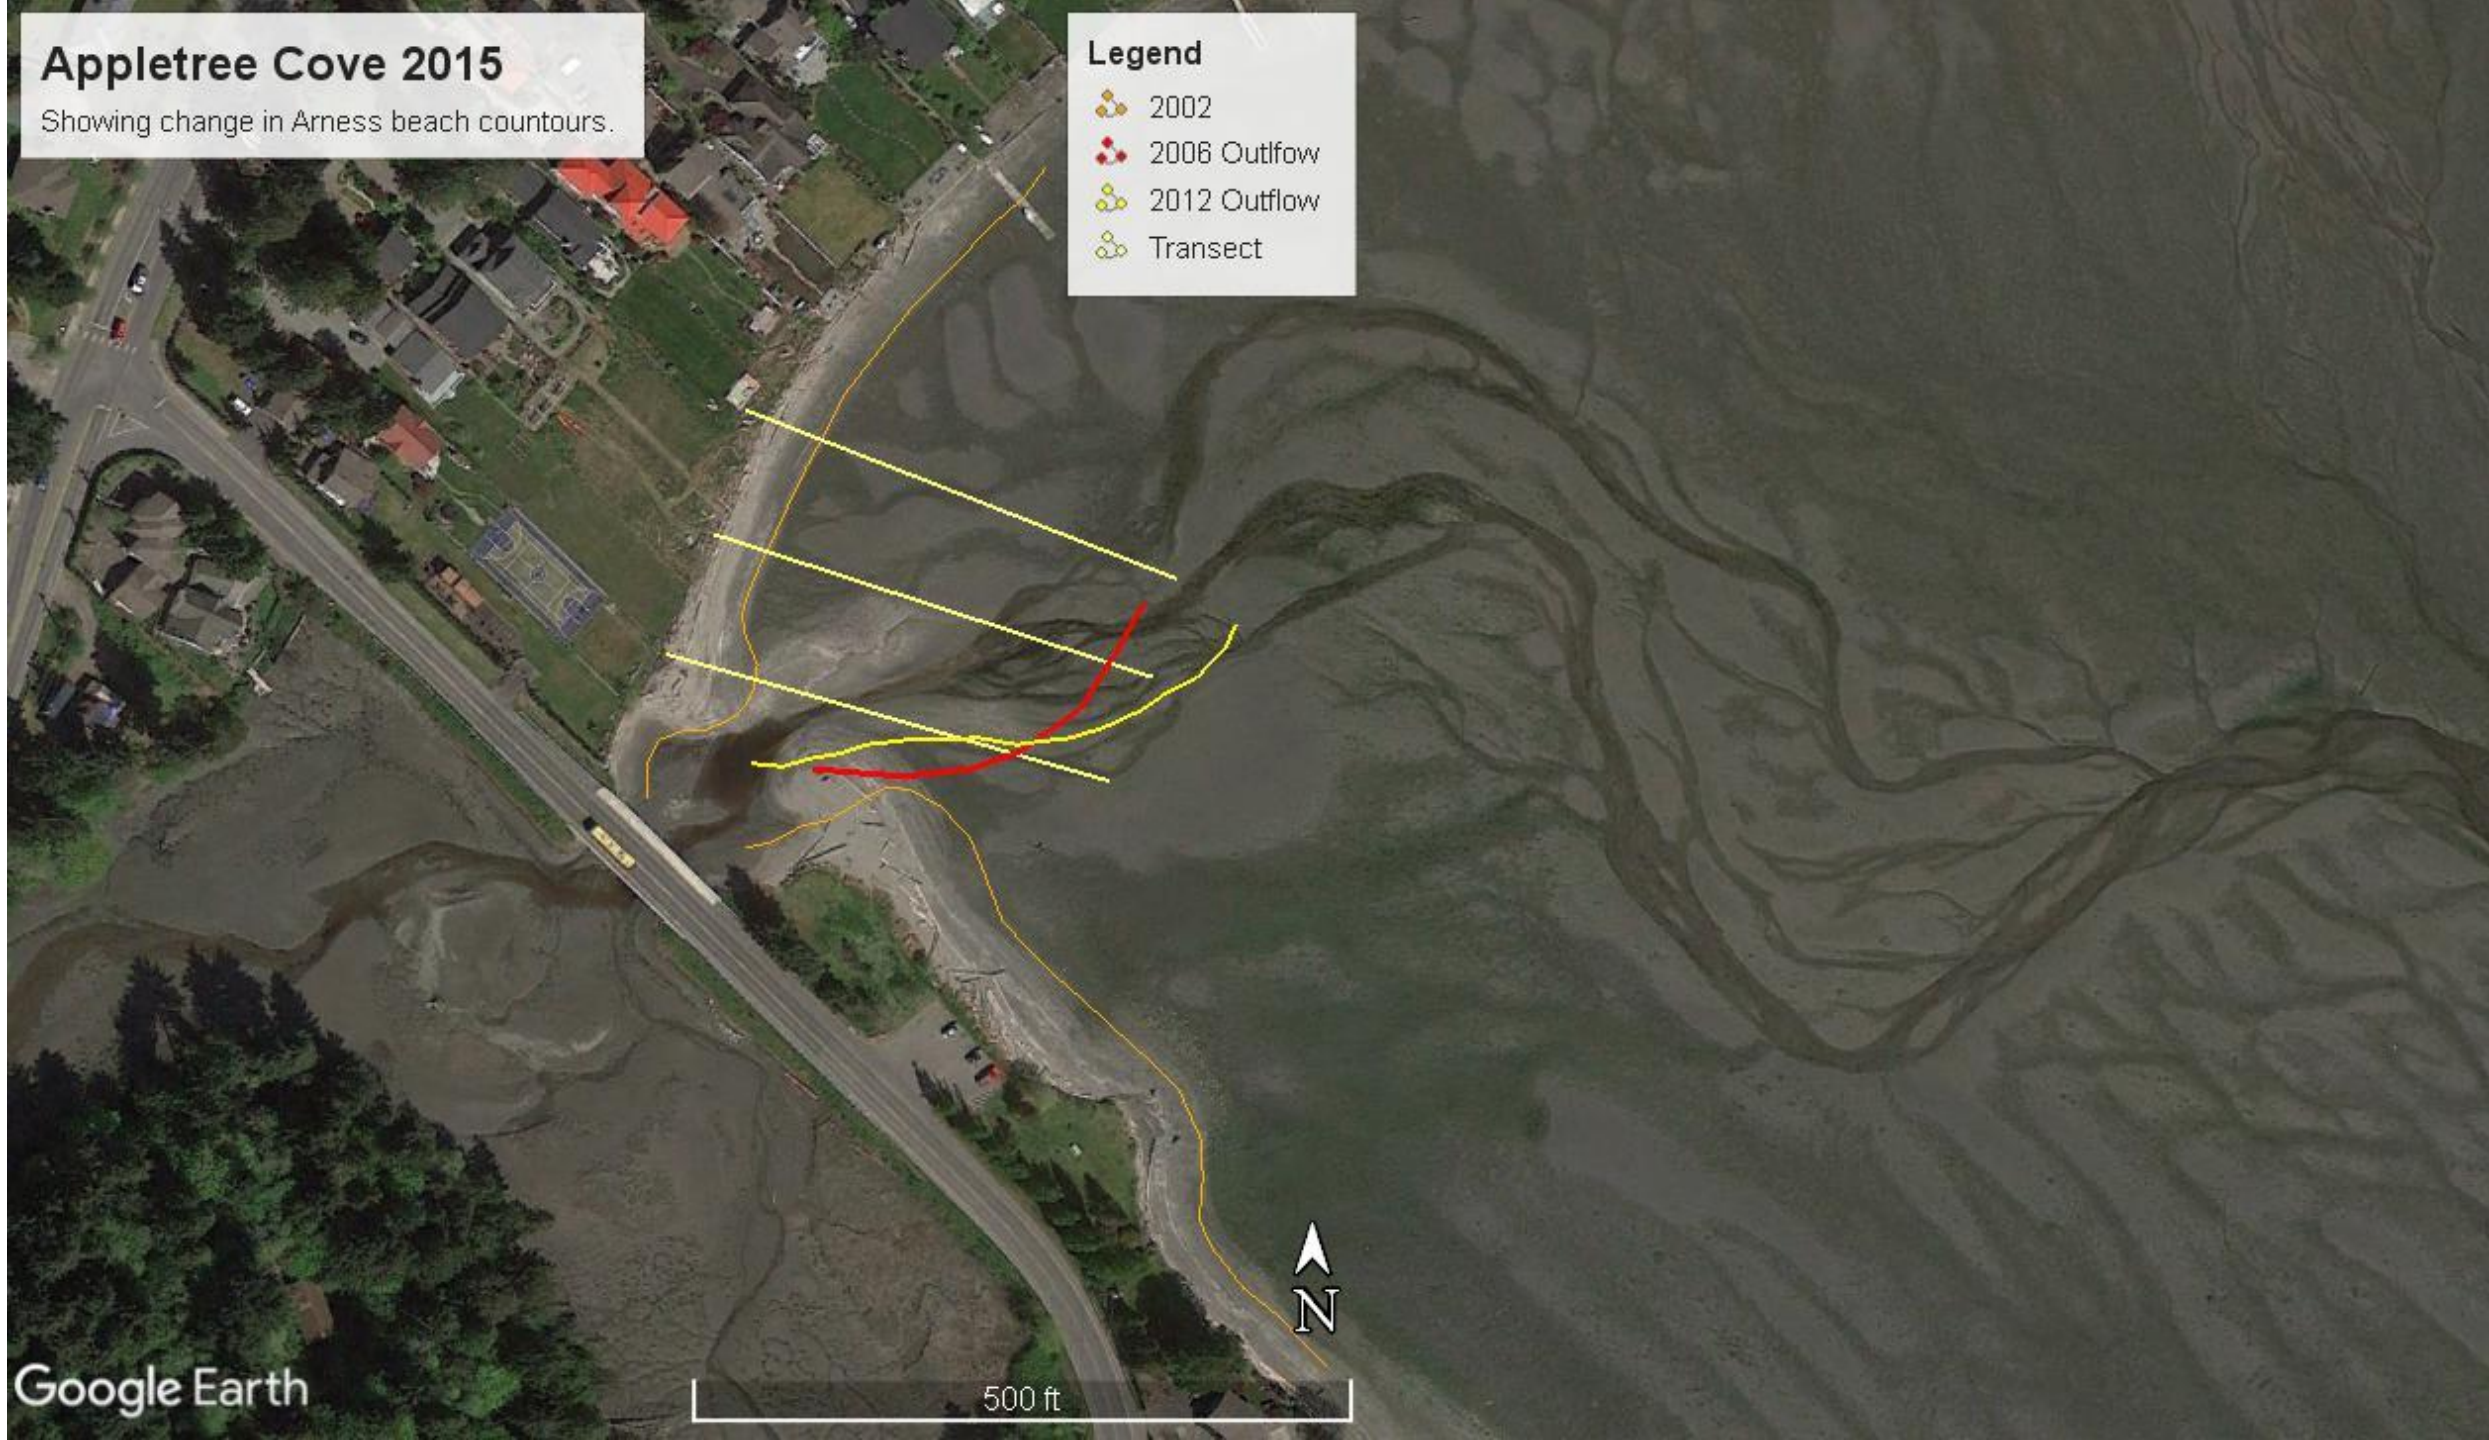
# Appletree Cove 2015

Showing change in Arness beach countours.

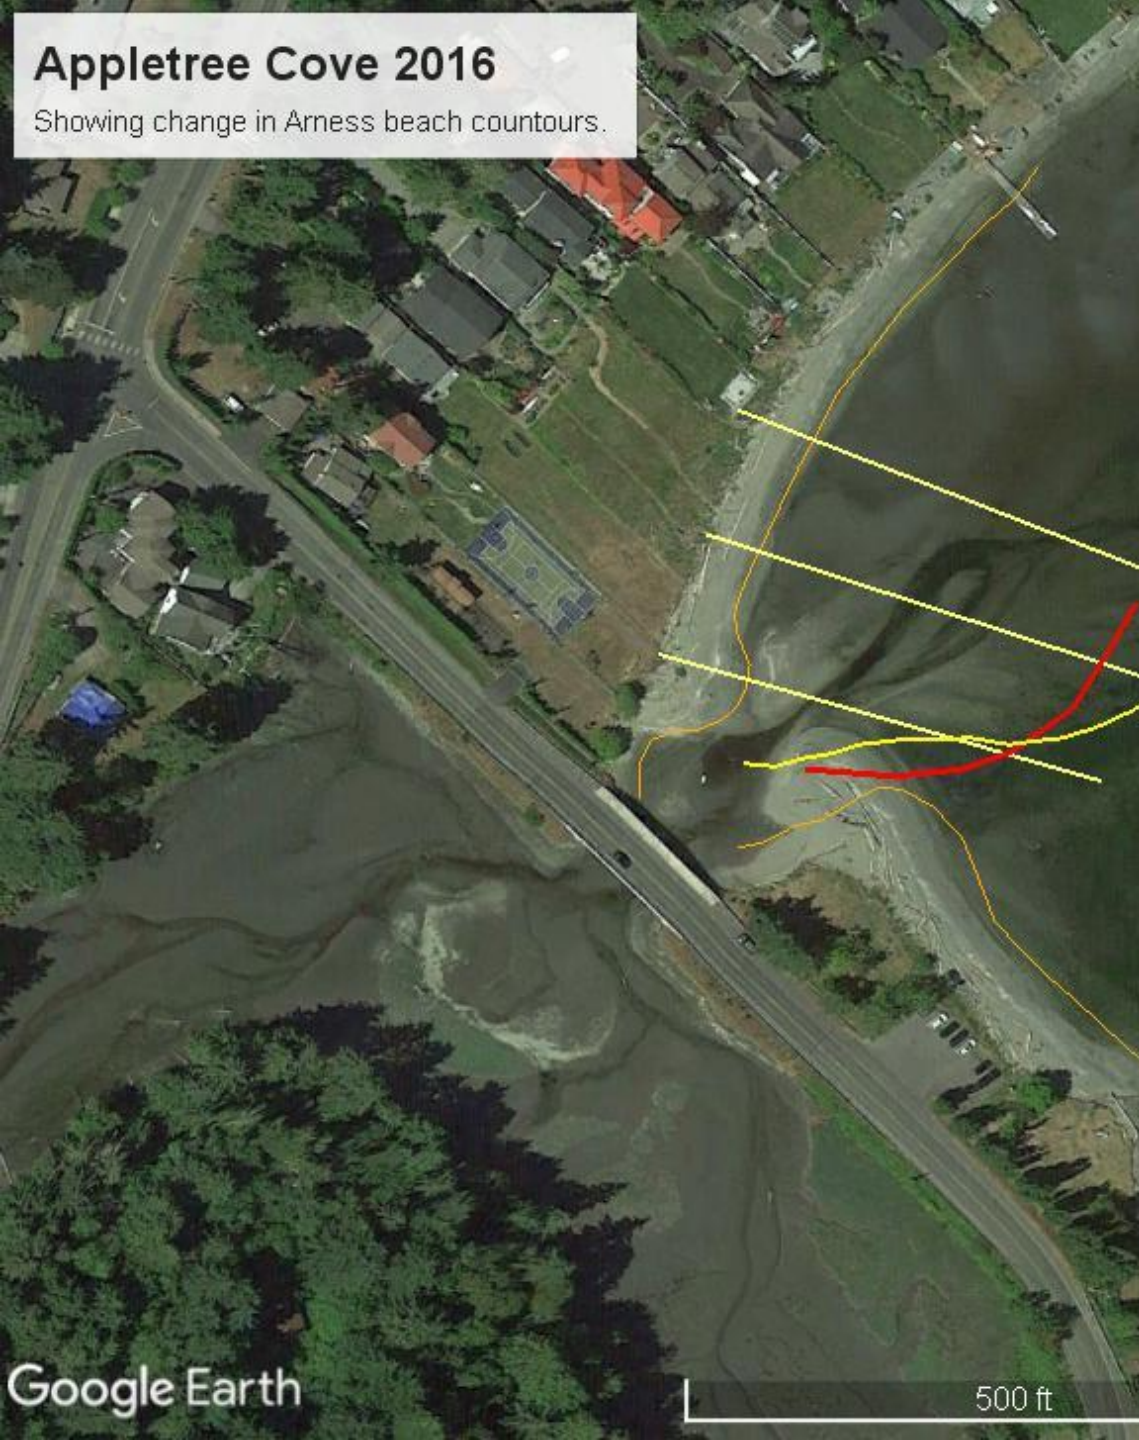
# Appletree Cove 2016

Showing change in Arness beach countours.

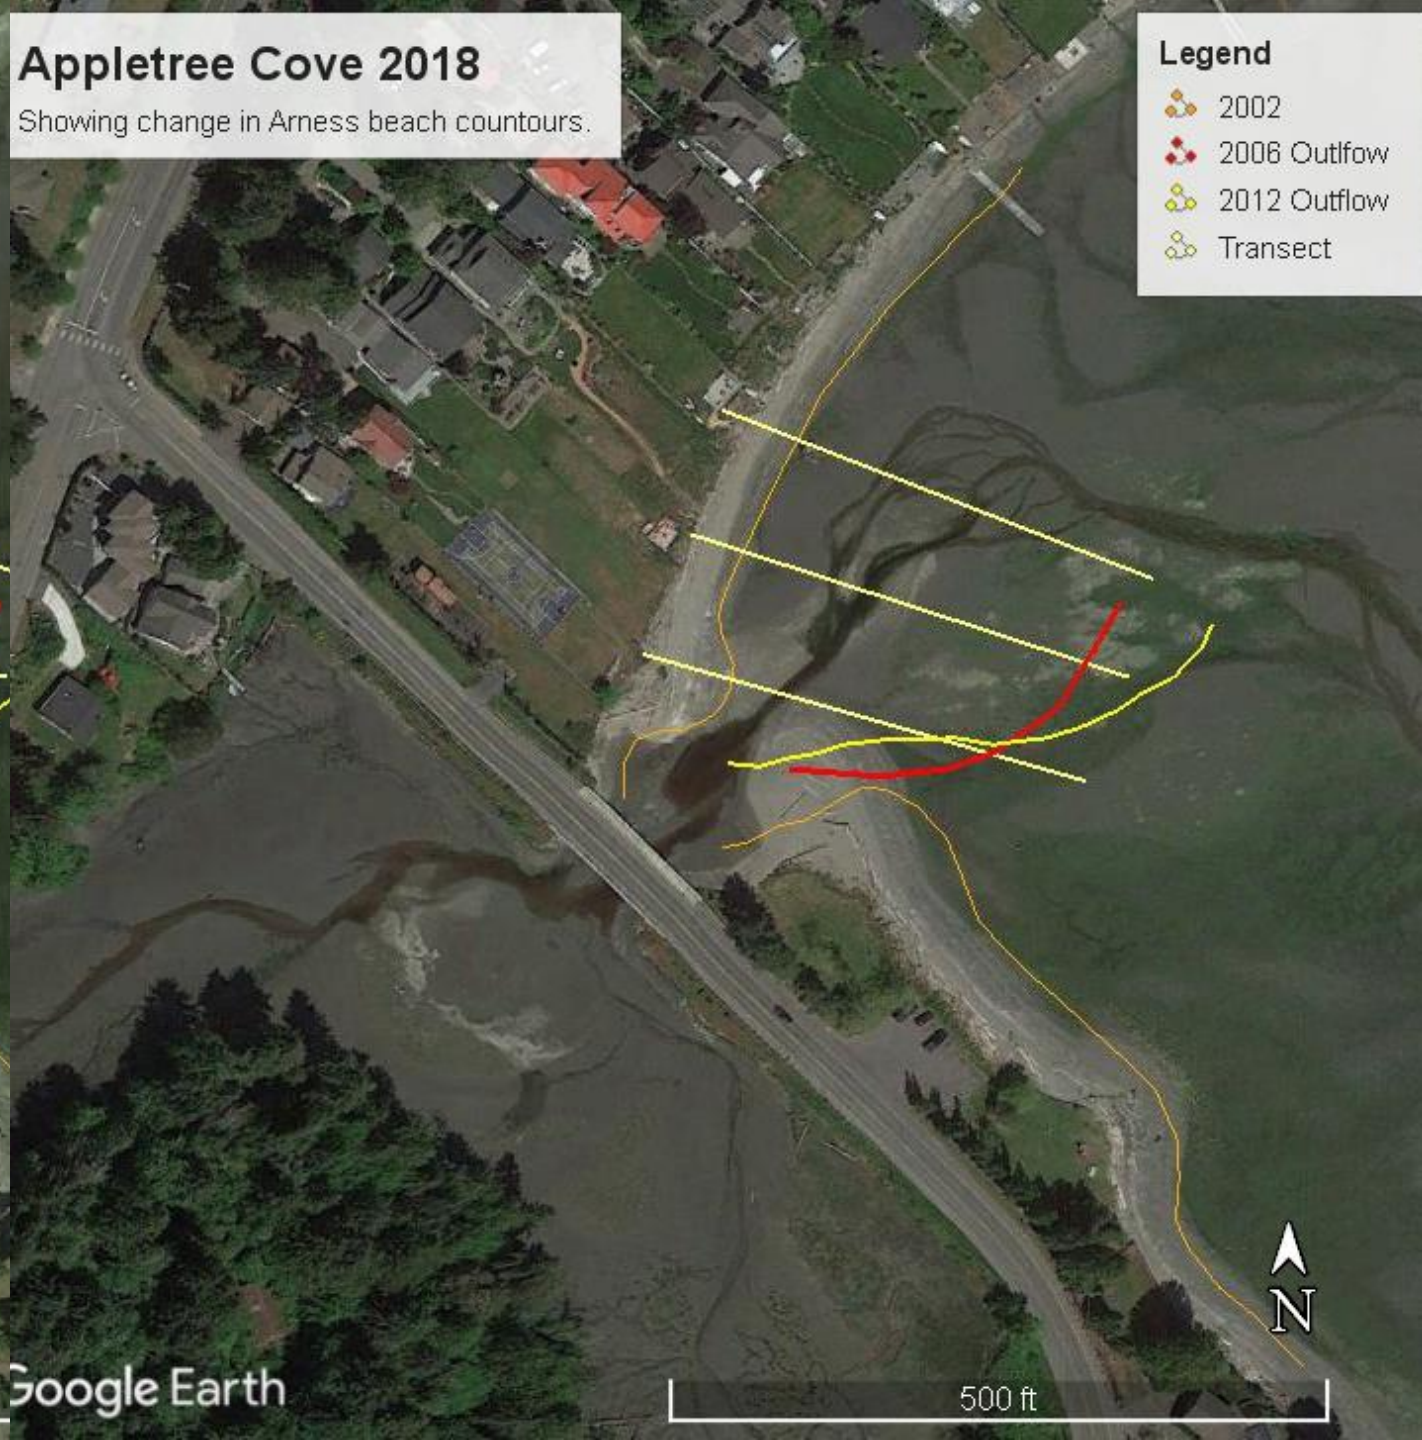
# Appletree Cove 2018

Showing change in Arness beach countours.
