**Joyful Work:  
Beach Profiling and Cove Sedimentation Edition**

# Beach Profiling

**Concerns by property owners prompted Stillwaters to conduct beach profiling to document changes in sedimentation patterns in the cove after culvert removal**

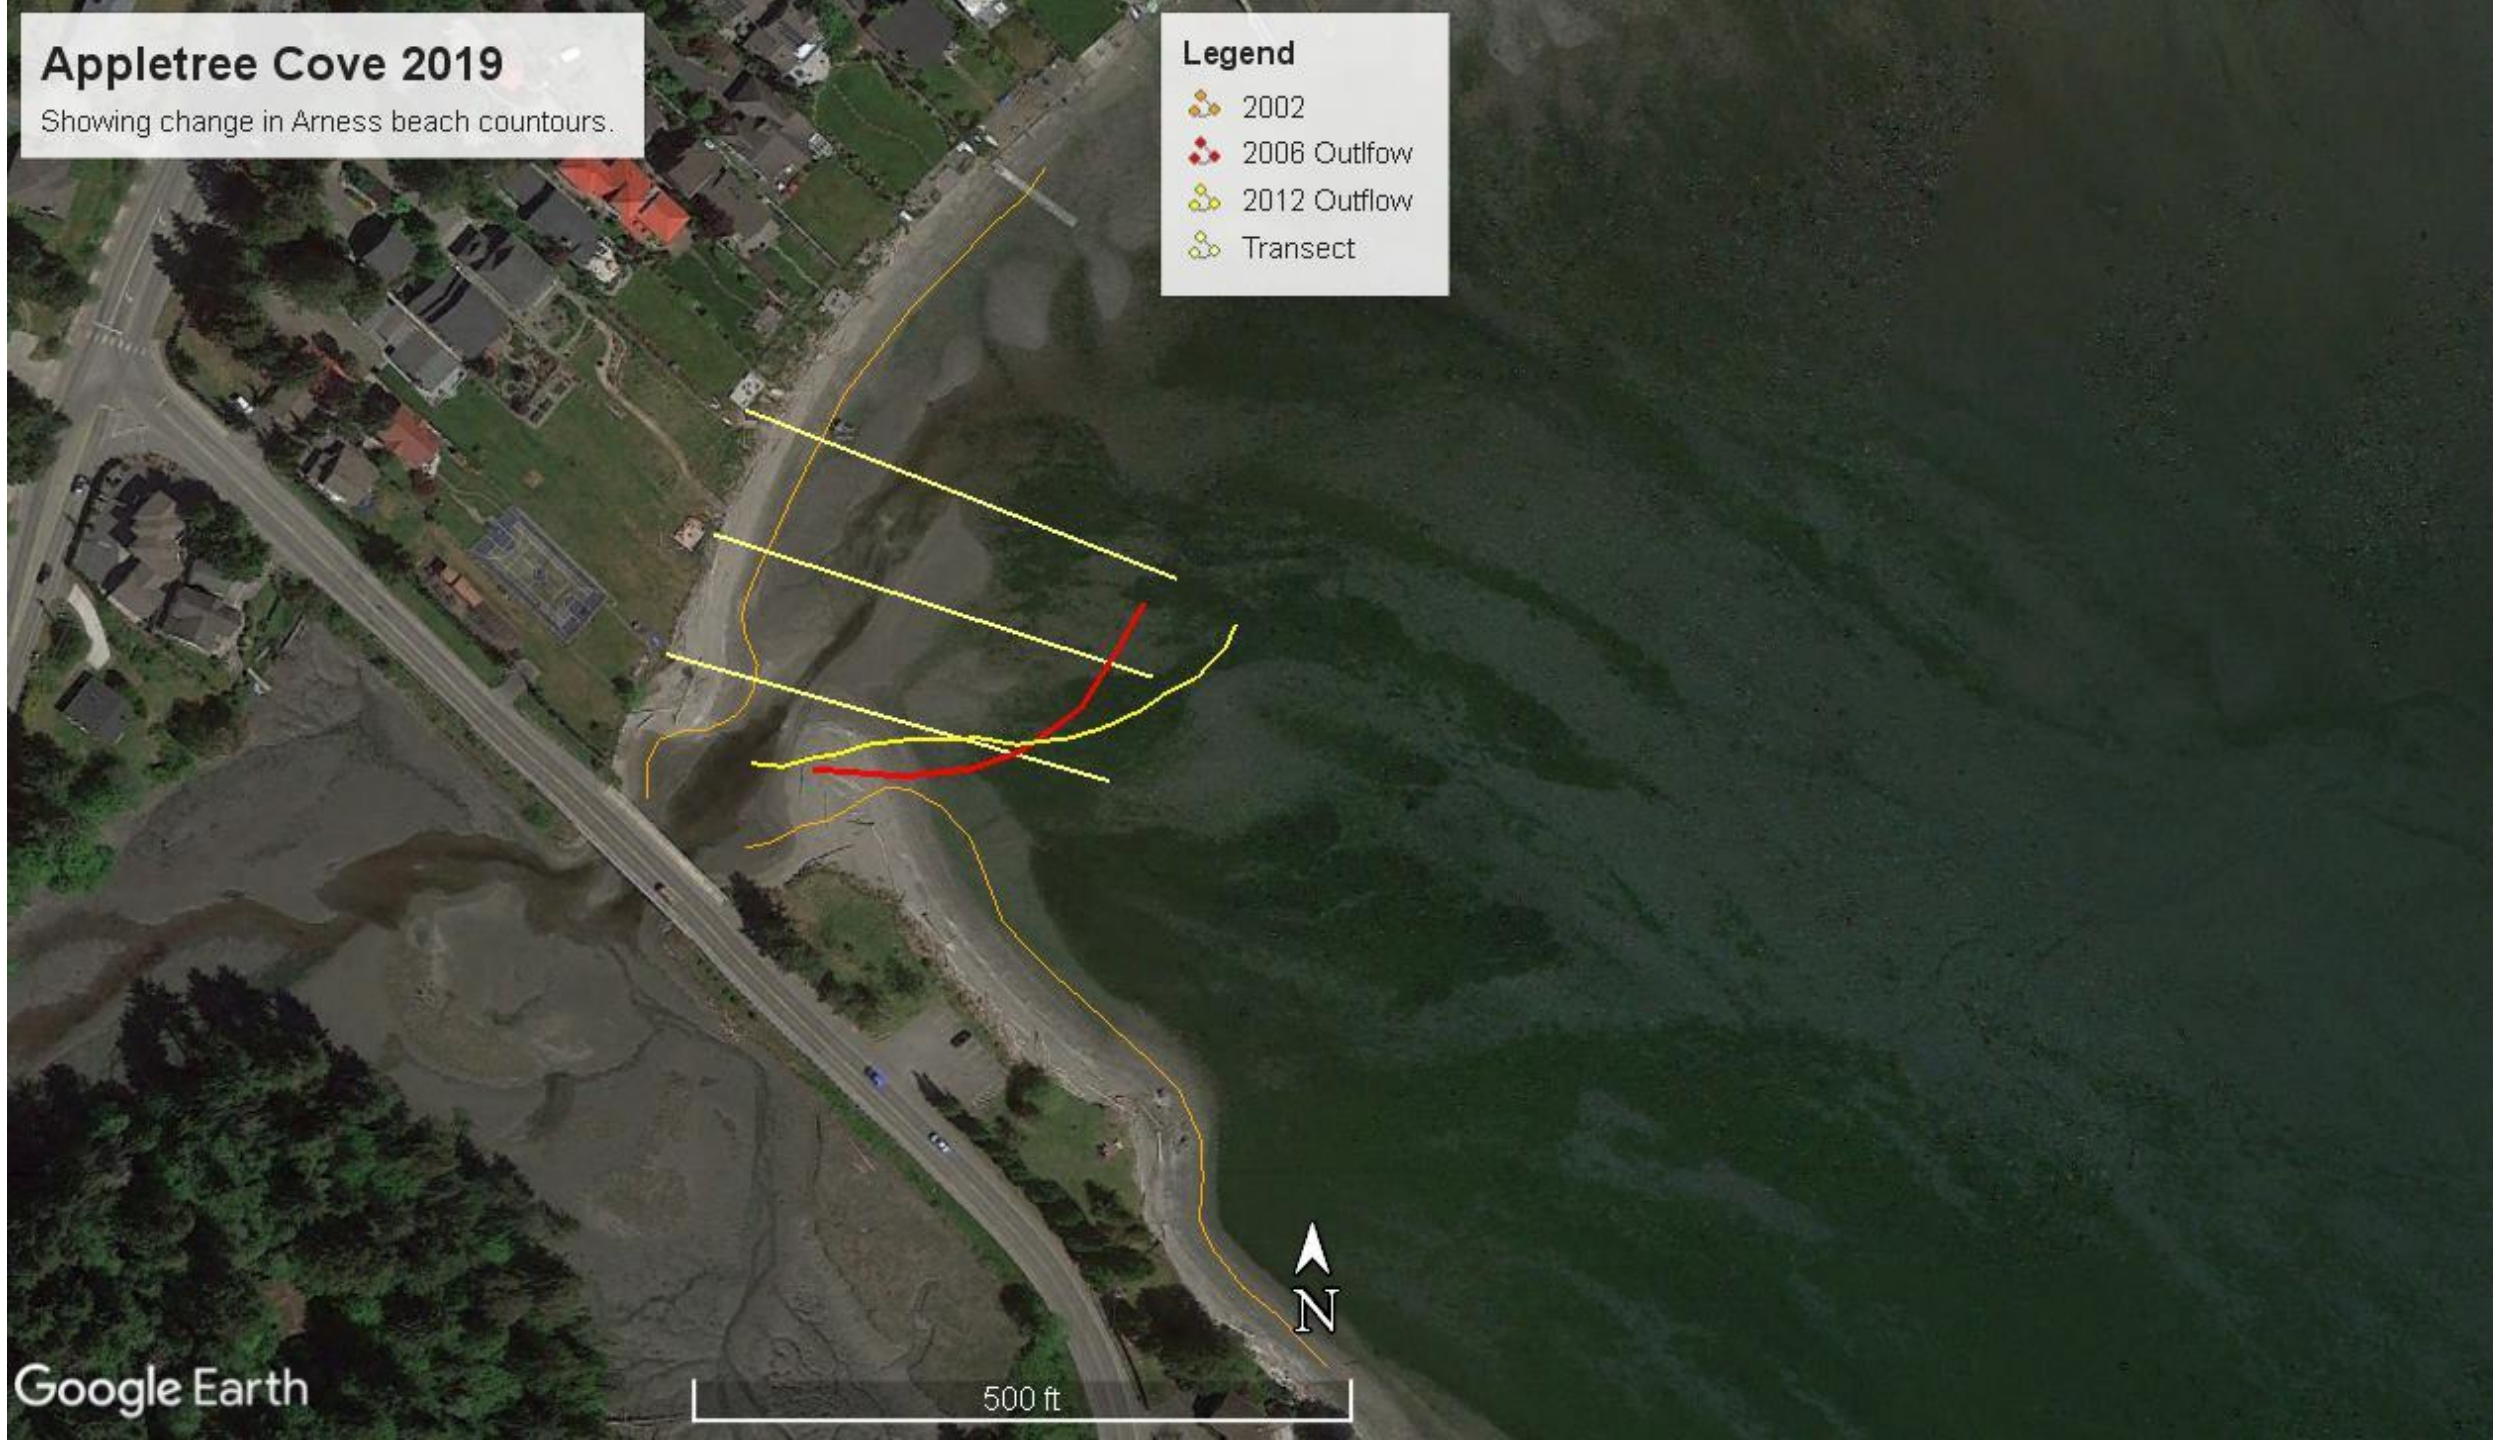
# Appletree Cove 2019

Showing change in Arness beach countours.
